JANUARY 2012

Transmission Oil Coolers

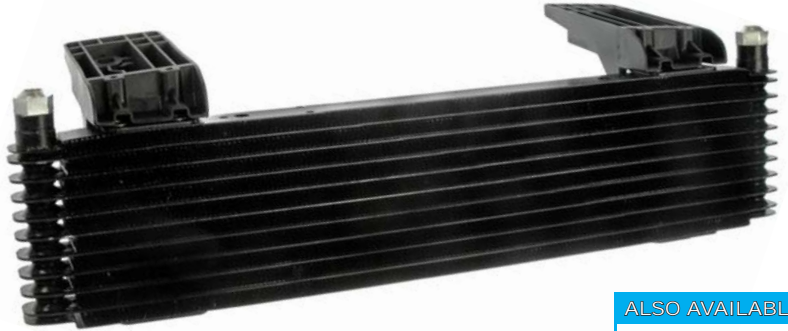
918-202
 F Series Pickup
 2008-04
 Mark LT
 2008-06

Air flows through the fins of the Transmission Oil Cooler to cool the transmission oil flowing through it

FAILURE MODE:

- Corrosion due to exposure to the elements
- Damaged by being hit or becoming clogged by road debris
- Damaged in a crash
- Clogs over time
- Replace with Transmission

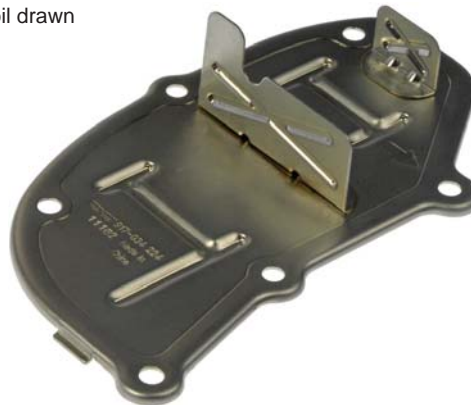
917-034
 Forester, Impreza
 2011-06
 Legacy
 2009-07

Oil Separator Cover

Cover located on the back of the Engine Block that separates oil drawn through the PCV system from the Intake Vacuum

Constructed of metal to eliminate
 warping of original plastic design

FAILURE MODE:

- Original plastic piece warps over time due to heat exposure
- Failure results in oil leakage

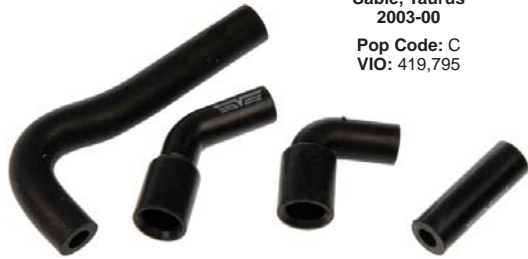
46027
 Sable, Taurus
 2003-00
 Pop Code: C
 VIO: 419,795

PCV Elbow Kit

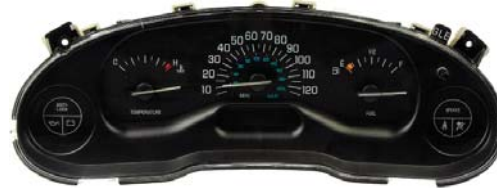
599-329
 Century, Regal
 1998-97
 Pop Code: SO
 VIO: 227,147

Remanufactured Instrument Clusters

Ready to Install – Fully Programmed with Mileage and VIN

FAILURE MODE:
 • Electrical burnout

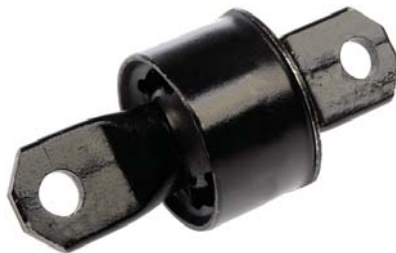
905-303 [RL]
 Focus
 2007-00
 Pop Code: C
 VIO: 1,546,848

Trailing Arm Bushing
